geebeempeep

**Maxford USA Antonov An-2 ARF**

By Ken Myers

August 2013

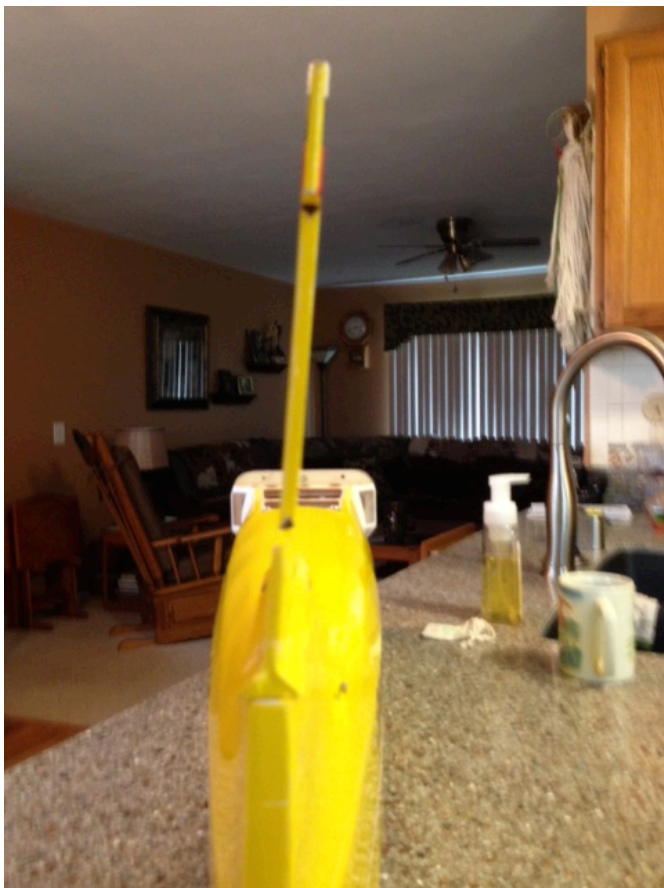
The first piece that I removed was the top wing center section. The 'plastic' top of the center section was cracked in two places. There were also two pieces of balsa floating around in the center section and obviously rattling when I turned it over to look at the bottom of the section. I was able to get one piece to fall out and the other required a straight pin and needle nose pliers. The cracks and 'extra' pieces can be seen in the photo. I believe the quality control guy must have missed them. I did

absolutely nothing to embellish the cracks. They are exactly as received.

On Friday, June 21, I emailed Maxford USA about the problems I had discovered. On Monday, June 24, the new center section arrived in the postal mail. **Wow, what fantastic service!**

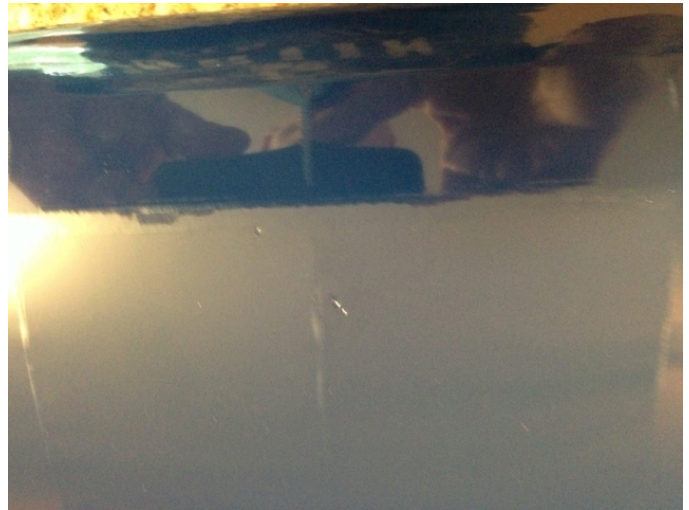
The triangle stock glued to the bottom of the vertical fin is 'crooked' and is not tapered to match the fuselage. The vertical fin, as received, was then taped onto the fuselage. The results can be seen in in the photo.

The rear of the 1/4"-triangle stock was not tapered to match the angle of the rear of the fuselage and 'hangs over' the rear of the fuselage on both sides.

On Friday, June 28, it was time to deal with the vertical stabilizer problem. The vertical fin with the previously hinged rudder was trial fitted. The covering was removed from the top of the horizontal stabilizer where the vertical fin would be glued. Without trying to correct the problem with the 1/4"-triangle stock on the right side of the vertical stabilizer, it was 30-minute epoxied to the fuselage and horizontal stabilizer. It was aligned vertically using a 90-deg triangle. Later, the gap, created by the misaligned 1/4"-triangle stock was filled with 30-minute epoxy.

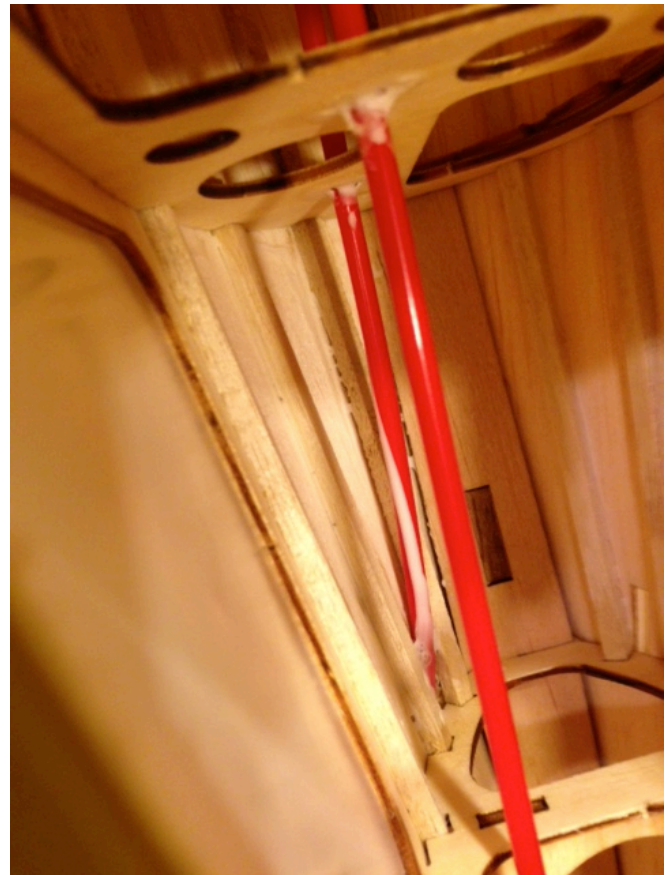
I removed some of the bottom covering at the tail so that I could inspect where the elevator pushrod entered the fuselage. I found that there is an extremely sharp curve/bend where the outer sleeve exits the fuselage. The binding is there, at the sharp curve/bend.

The sharp bend can be seen in the rod with the whitish glue smeared on it on the left in the photo.

To eliminate the binding, I decided to replace the pre-installed, and unusable, pushrod with a Sullivan Flexible Gold-N-Rods Stock #504. This required a whole morning of work with a soldering iron, Dremel rotary tool, razor blades, X-acto handle and #11 blade and drill bits.

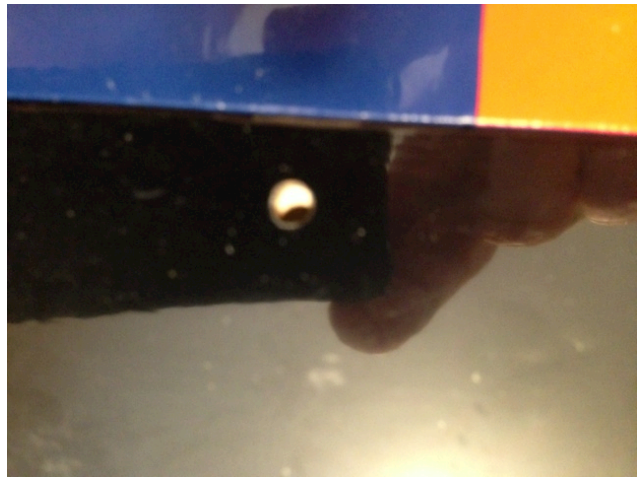
A bigger problem was that the tab for the Maxlok key, that is glued in the lower right wing panel, was not inserted to the correct depth into the

wing. This caused the misalignment which can be seen in the photo.

The hole in the tab was filled with a piece of dowel and then a new hole drilled in the correct location for the Maxlok key insertion.

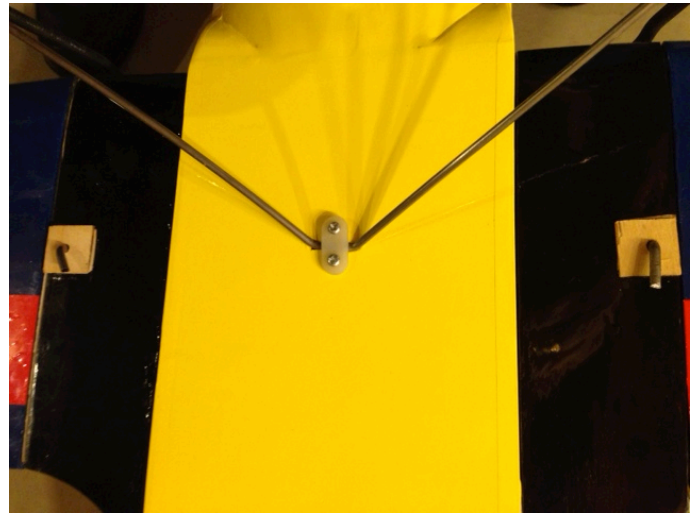
A maiden flight was attempted at about 6 p.m. The wind was blowing across the field from behind the flight line at about 10 mph to 12 mph. The takeoff run was from left to right. As the plane lifted, the wind got under the right wing panels and it started to roll to the left. The throttle was shut down with the plane approximately four feet above the ground while the right aileron was applied. The plane landed on its nose and right wing panels. Remarkably there was no damage of any kind, except that the lower right Maxlok key hole, in the lower right fairing, was elongated as the Maxlok key pulled outward toward the tip of the bottom wing panel. Flying was over for the day.

After returning home, 1/16" birch plywood was cut into 3/4" squares and drilled for the Maxlok key diameter. The squares were 30-minute epoxied to the bottom of the lower wing fairings over the Maxlok key holes, which only go through the extremely thin wood on the bottom of the lower wing fairing. The 3/4" square 1/16" birch plywood was painted black.
