geebeempeep

**Maxford USA Antonov An-2 ARF**

By Ken Myers

August 2013

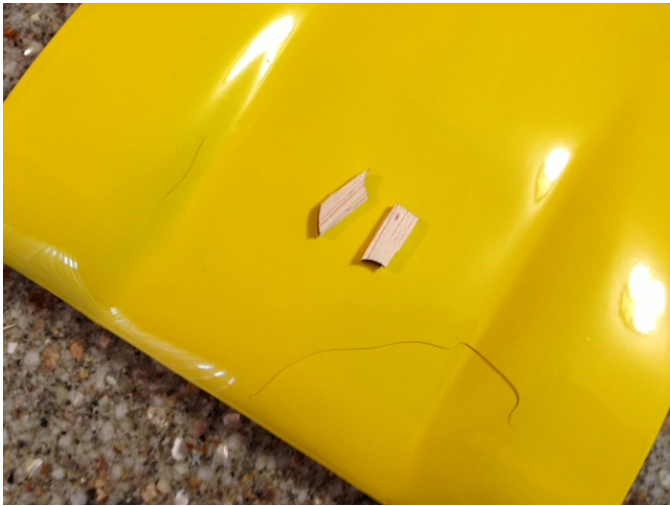
The first piece that I removed was the top wing center section. The 'plastic' top of the center section was cracked in two places. There were also two pieces of balsa floating around in the center section and obviously rattling when I turned it over to look at the bottom of the section. I was able to get one piece to fall out and the other required a straight pin and needle nose pliers. The cracks and 'extra' pieces can be seen in the photo. I believe the quality control guy must have missed them. I did

absolutely nothing to embellish the cracks. They are exactly as received.

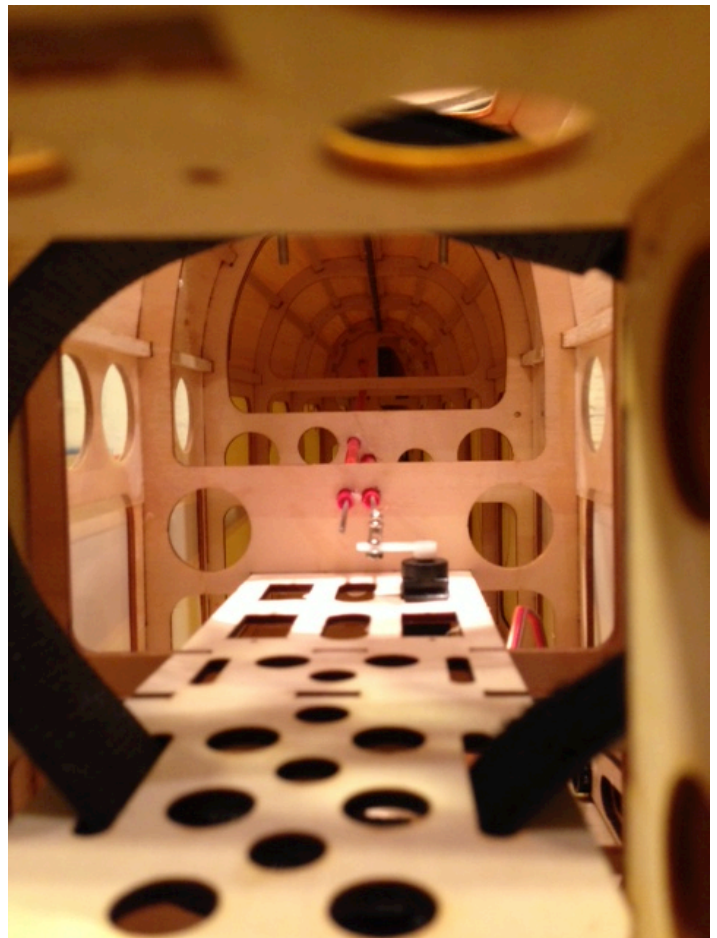
The rudder servo was installed first using the supplied pushrod and EZ Link. The servo was too low when setting in the servo tray and it put another bend and bind in the already binding rudder pushrod. The offending preinstalled rudder pushrod was removed with as much vexation as the elevator

pushrod and replaced with another Sullivan Flexible pushrod.

I found that the control horn on the elevator needed to be repositioned and angled to the angle of the pushrod and aligned to the hinge line. The rudder control horn was also repositioned and moved forward so that the holes in the control horn aligned with the rudder hinge line. The control horn also had to be trimmed near the bottom most hole to allow proper movement of the rudder.

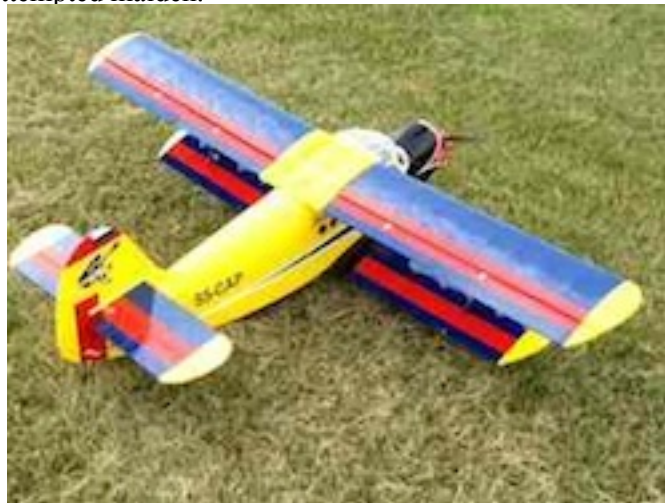
This is Ken Myers' Maxford USA Antonov An-2 Colt ARTF (almost-ready-to-fix). The "assembly" report is in this *Ampeer*. It flies well, but there were some problems during assembly that Maxford **immediately took care of**.

Photo taken at the Midwest field on July 3 before the attempted maiden.
